**SCREENING REPORT FOR AN ENVIRONMENTAL AUTHORIZATION AS  
REQUIRED BY THE 2014 EIA REGULATIONS – PROPOSED SITE  
ENVIRONMENTAL SENSITIVITY**

**Project name:** EA Part 2 Amendment

**Project title:** Erf 28005, George

## **THE PROPOSED PART 2 EA AMENDMENT FOR RESIDENTIAL DEVELOPMENT ON ERF 28005, GEORGE**

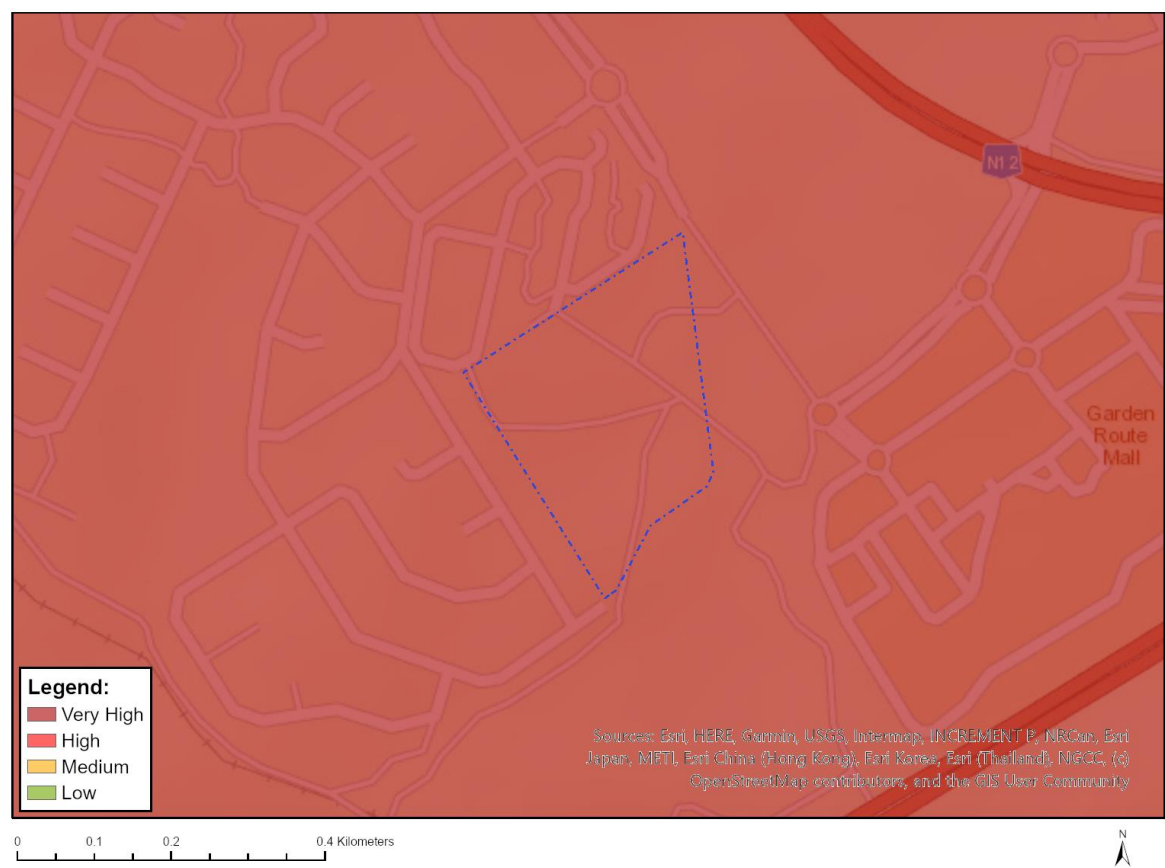
MAP OF RELATIVE AQUATIC BIODIVERSITY THEME SENSITIVITY

| Sensitivity | Feature(s) |
|---|---|
| Very High | SWSA (sw)_Outeniqua |

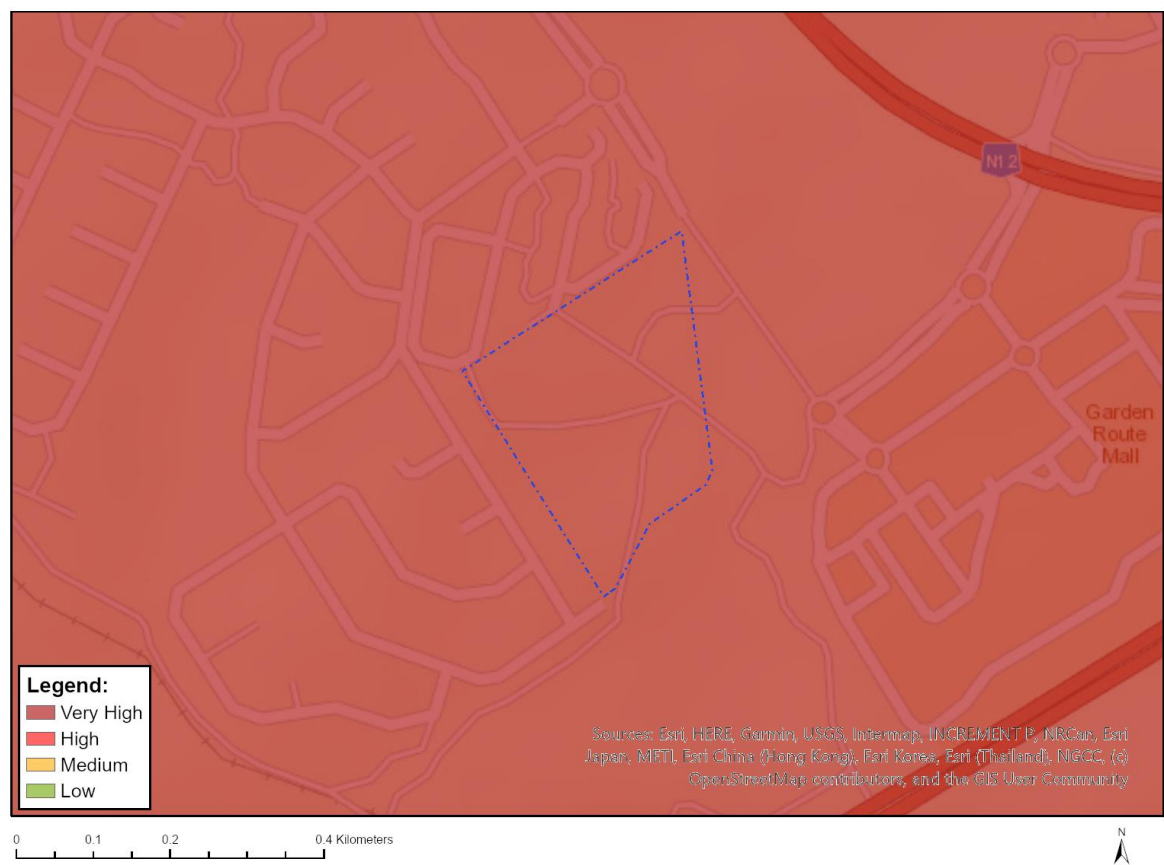
# MAP OF RELATIVE ARCHAEOLOGICAL AND CULTURAL HERITAGE THEME SENSITIVITY

| Sensitivity | Feature(s) |
|---|---|
| Very High | Within 2km of a Grade II Heritage site |

Heritage Western Cape has issued a permit for the development of the site in keeping with the 2013 EA and accordingly agrees with a lower rating. It is recommended that it be negligible or very low in view of the fact that it has been fully serviced for development that can commence at any time without any further heritage or environmental authorisation process.

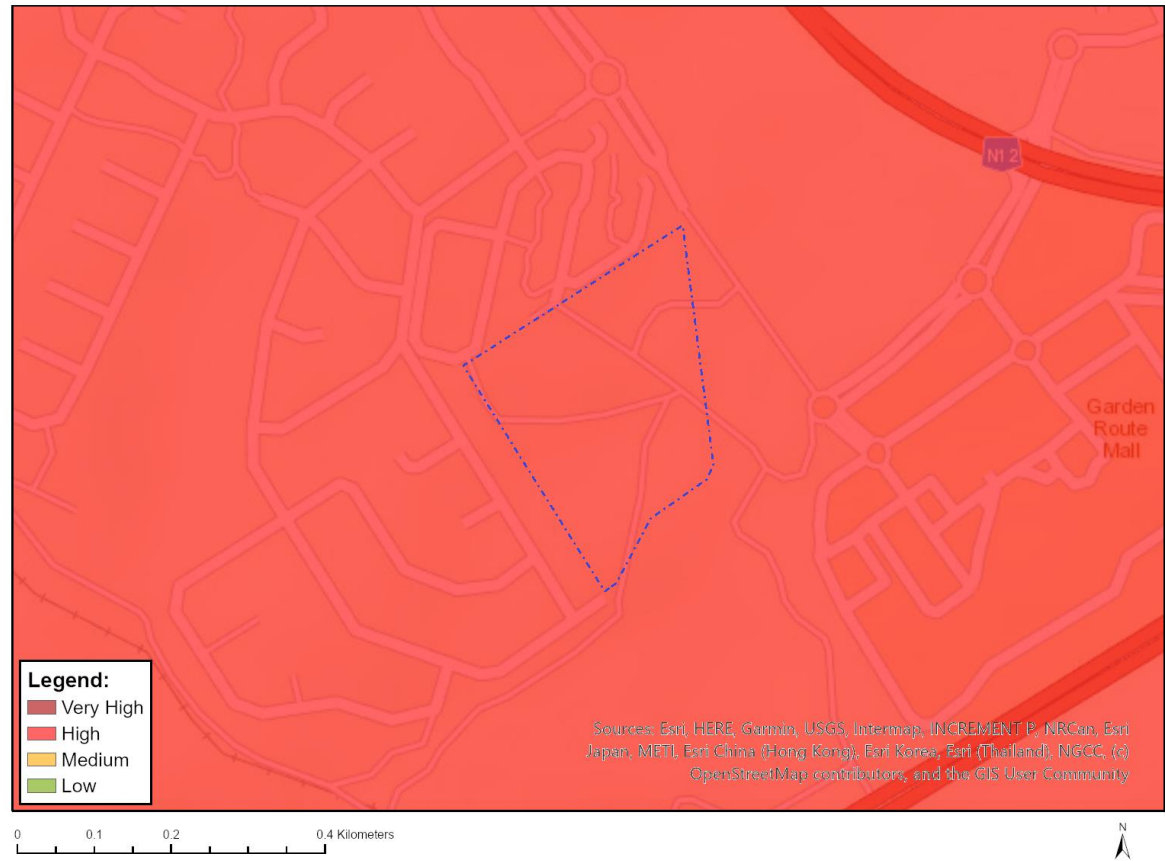
MAP OF RELATIVE CIVIL AVIATION THEME SENSITIVITY

| Sensitivity | Feature(s) |
|---|---|
| Medium | Within 5 km of an air traffic control or navigation site |

Disagree with the rating. It is recommended that it be negligible or very low in view of the existing rights and permitted use and distance to civil aviation infrastructure.

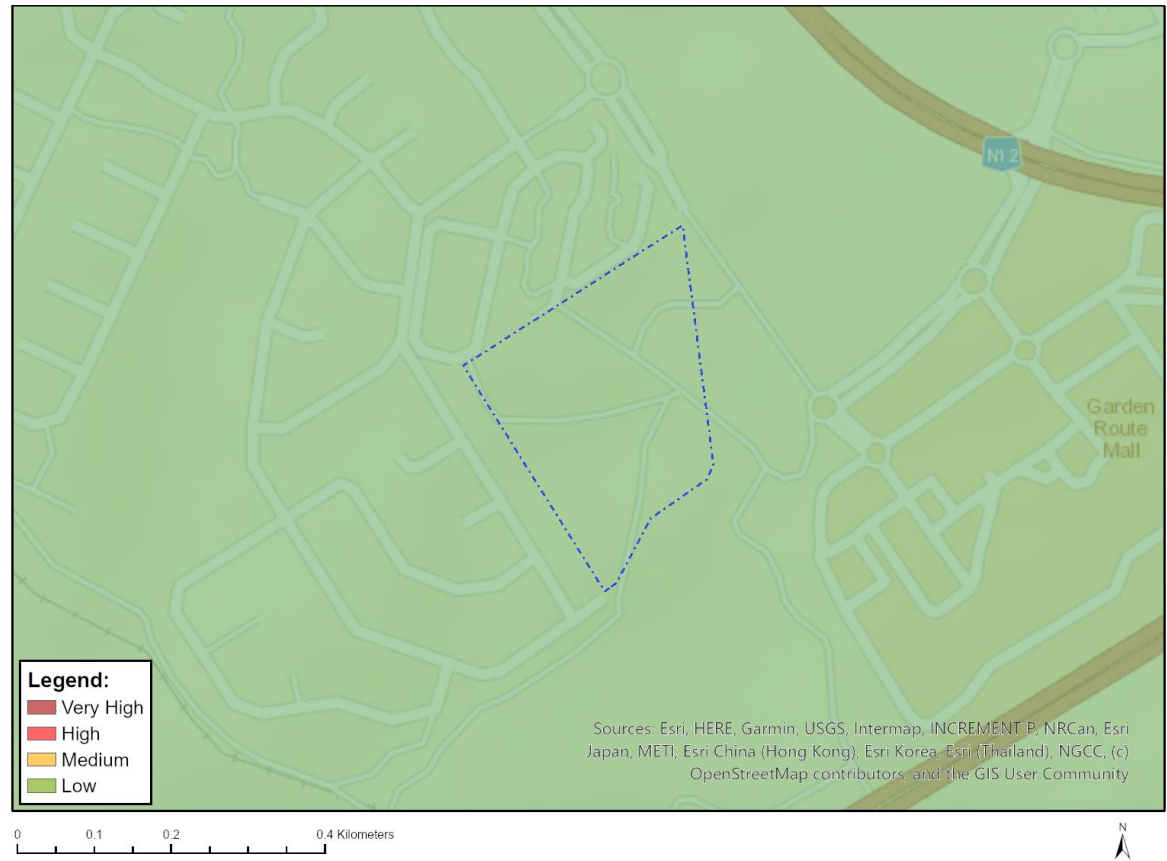
MAP OF RELATIVE DEFENCE THEME SENSITIVITY

| Sensitivity | Feature(s) |
|---|---|
| Low | Low Sensitivity |

Agreement with the rating in general. It is recommended that it be negligible or very low in view of the existing use and distance to any defence infrastructure. The site is not located close to any national key point, or strategic infrastructure and the intended use thereof does not pose a threat to national security.

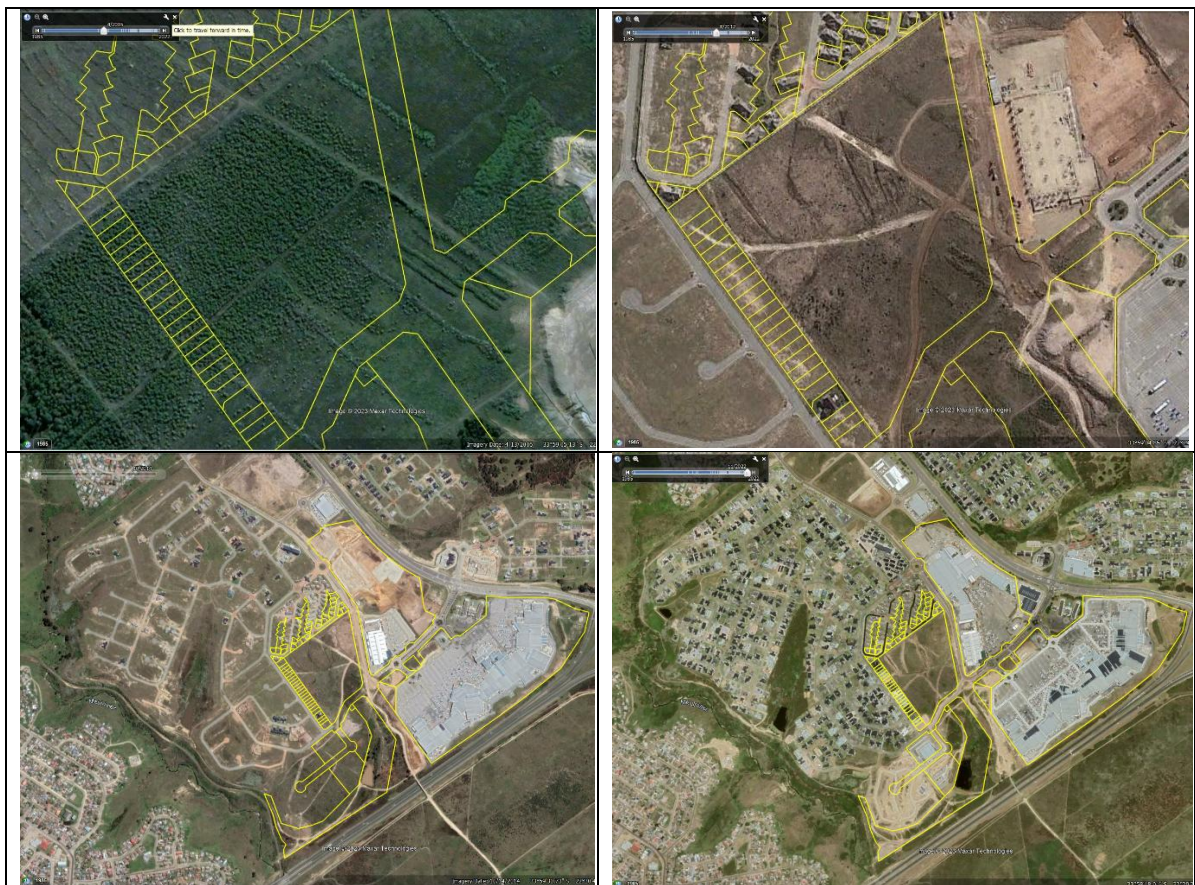
Figure 6: Site transformation: 2005, 2012, 2014, and 2022

The desktop assessment of the site sensitivity from the perspective of the authorised development and use of the site as per the 2013 EA.

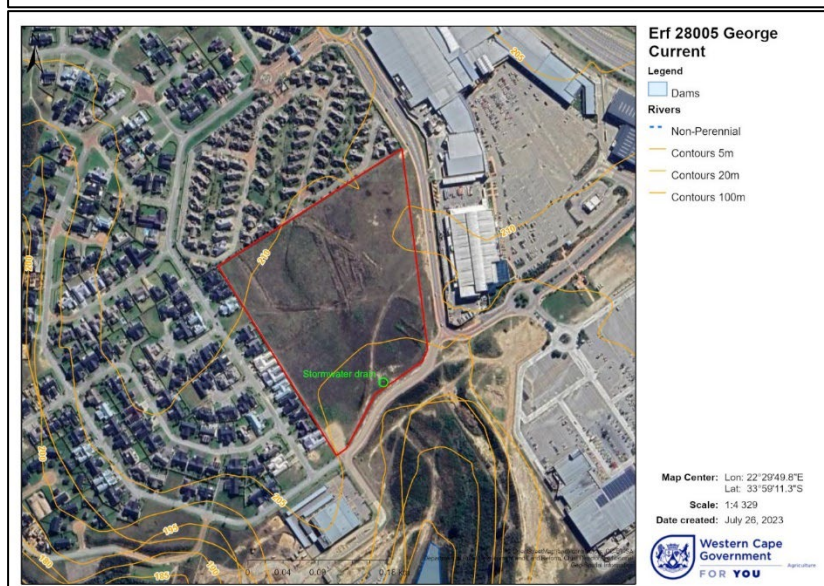
Figures 7-9 indicate disturbance on Erf 28005 between 2000 and 2023

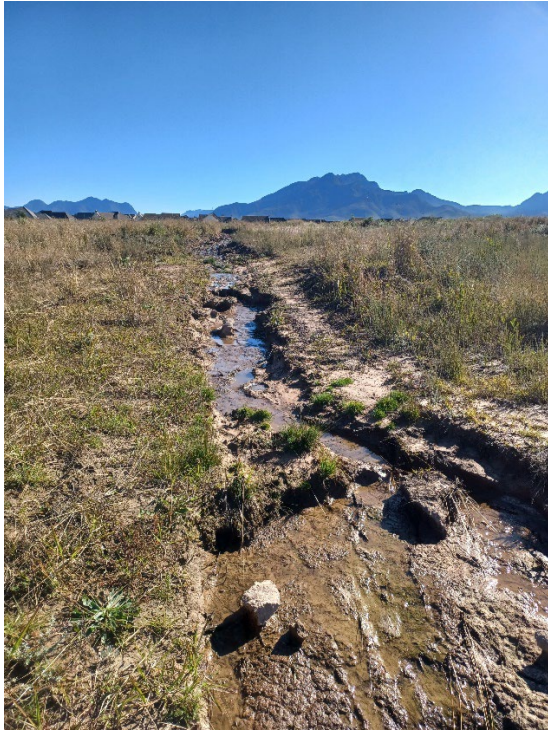
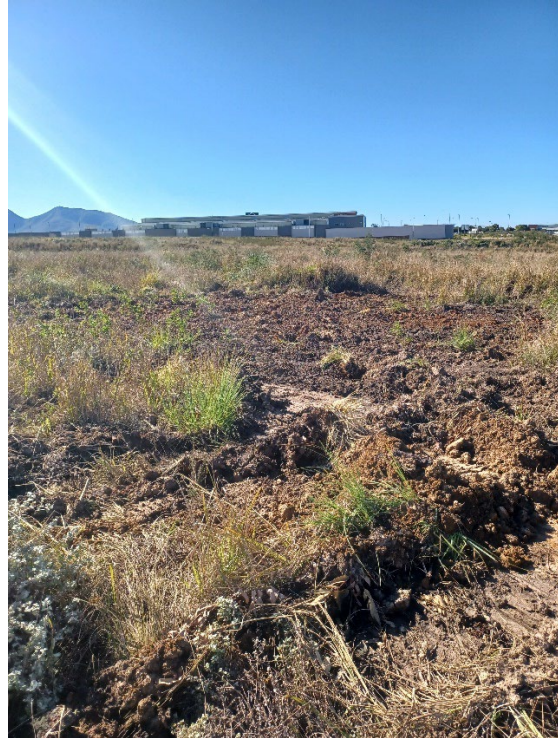
Figures 10 & 11 indicate the level of transformation and disturbance on Erf 28005

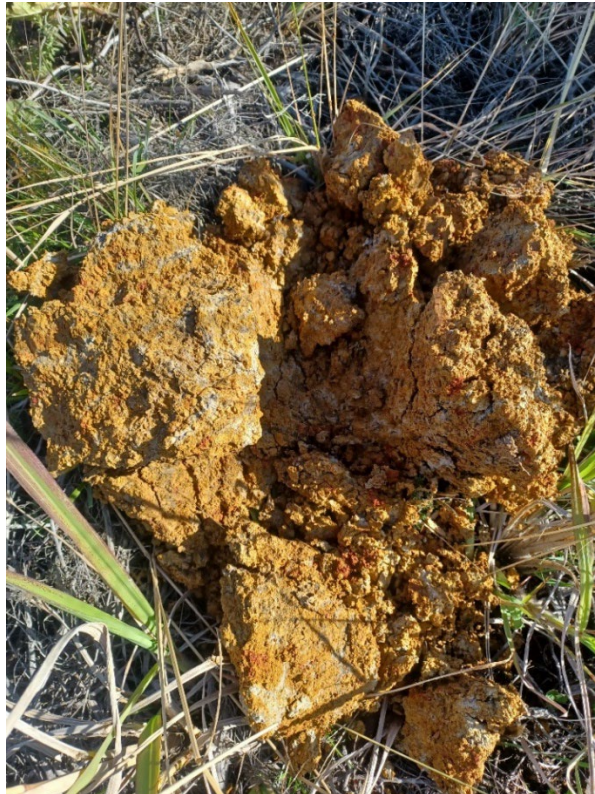
**Figure 13. Mottled red soil with a high clay content.**

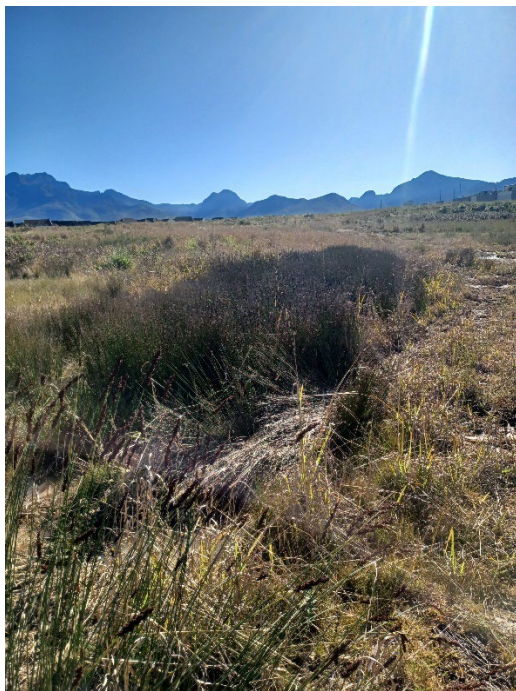
**Figure 14. Small Juncus dominated wetland**

Most of the study area does not contain vegetation typically adapted to saturated soil. Two small artificial wetlands have developed on the property due to stormwater directed over the property from Blue Mountain Village and altered drainage by construction of a filled road to the south of the property. The wetland in the south is dominated by *Juncus* sedges and drains across the dirt road towards the stormwater drain (figures 14, 15, 17). The wetland in the north against the boundary fence is dominated by *Typha* bulrush, with shorter herbaceous vegetation and grasses. Frog calls were observed at both wetlands, with a greater diversity of calls at the northern wetland.

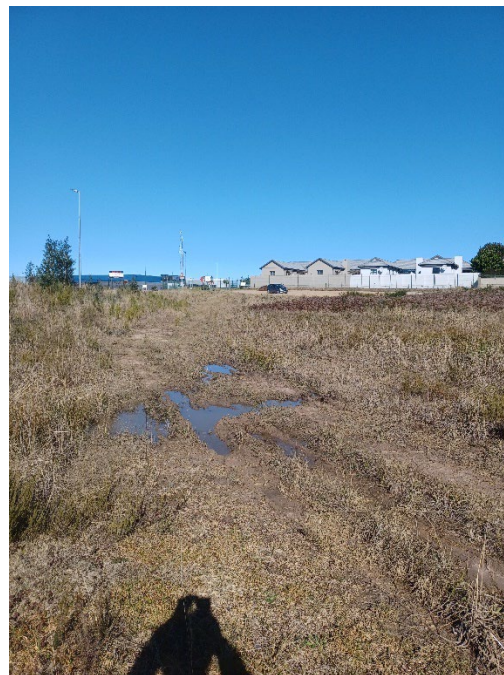
**Figure 15. Water draining from the small wetland**

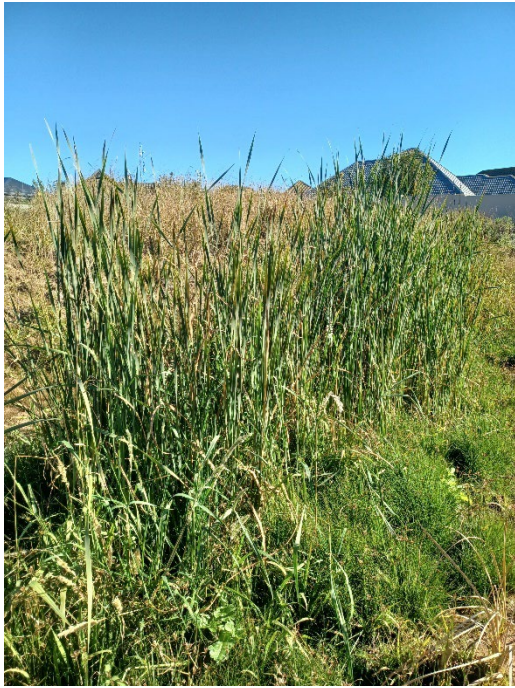
**Figure 16. Typha dominated wetland**

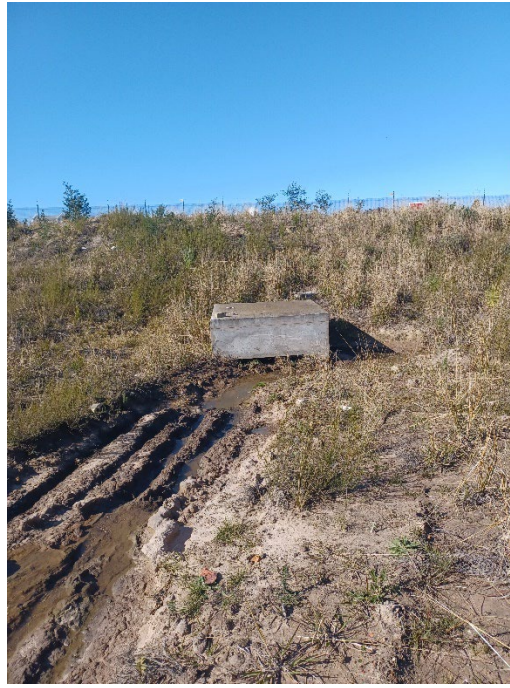
**Figure 17 Stormwater drain in the south**

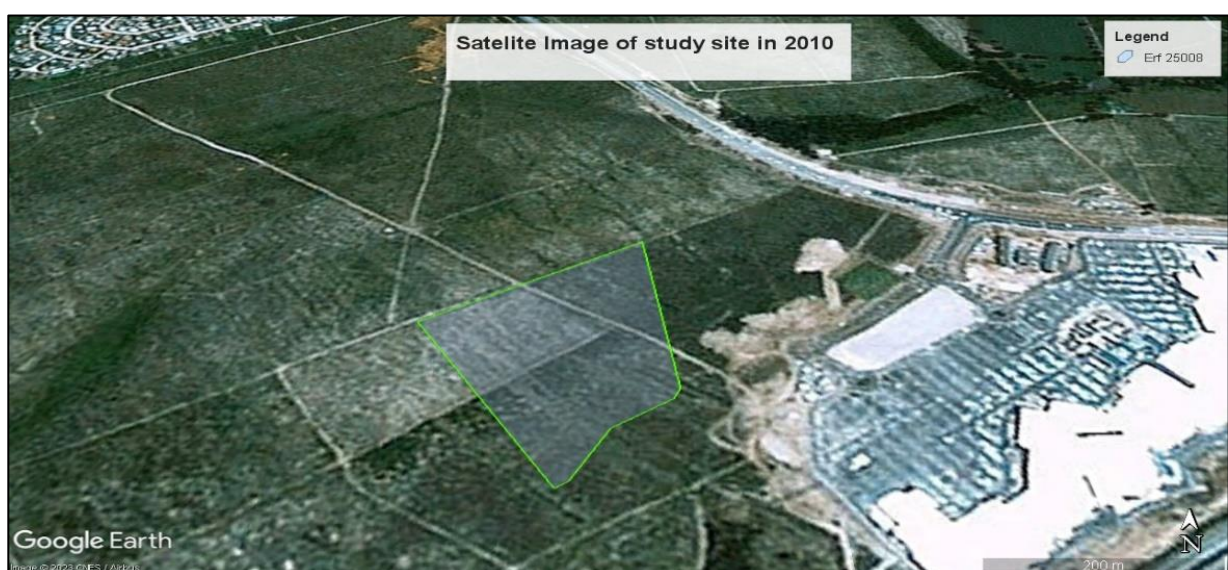
Figure 1: Satellite Image showing the study site at the time of the Environmental Authorisation Process in 2010 (Google Earth).

Virdus Works Environmental was tasked with drafting a letter to the catchment management agency to provide an overview of why the actions in terms of the National Water Act, Act no. 36 of 1998, do not apply to the planned activity on Erf 25008, George, Western Cape. The reason for the letter is in response to concerns that were raised over a potential wetland on the above-mentioned property. A desktop study and site visit however indicated that this is not the case, and that water on the property is from stormwater runoff from the abutting property. The property forms part of the greater Garden Route East and Eden Meander multi-phased development, which was approved by the Department of Environmental Affairs and Development Planning (DEA&DP) on 22 August 2011. During the environmental authorisation process that was done by Calidris Development Management Services and the accompanying specialist assessments, no reference has been made to a potential wetland on Erf 25008. At the time, Erf 25008 was still formed part of Portion 22 of Farm Kraaibosch, where it was used for Agriculture in the past. See Figure 1 below for a historic satellite image of the site in 2010. From the above, it is evident that no wetland occurred on the property historically.

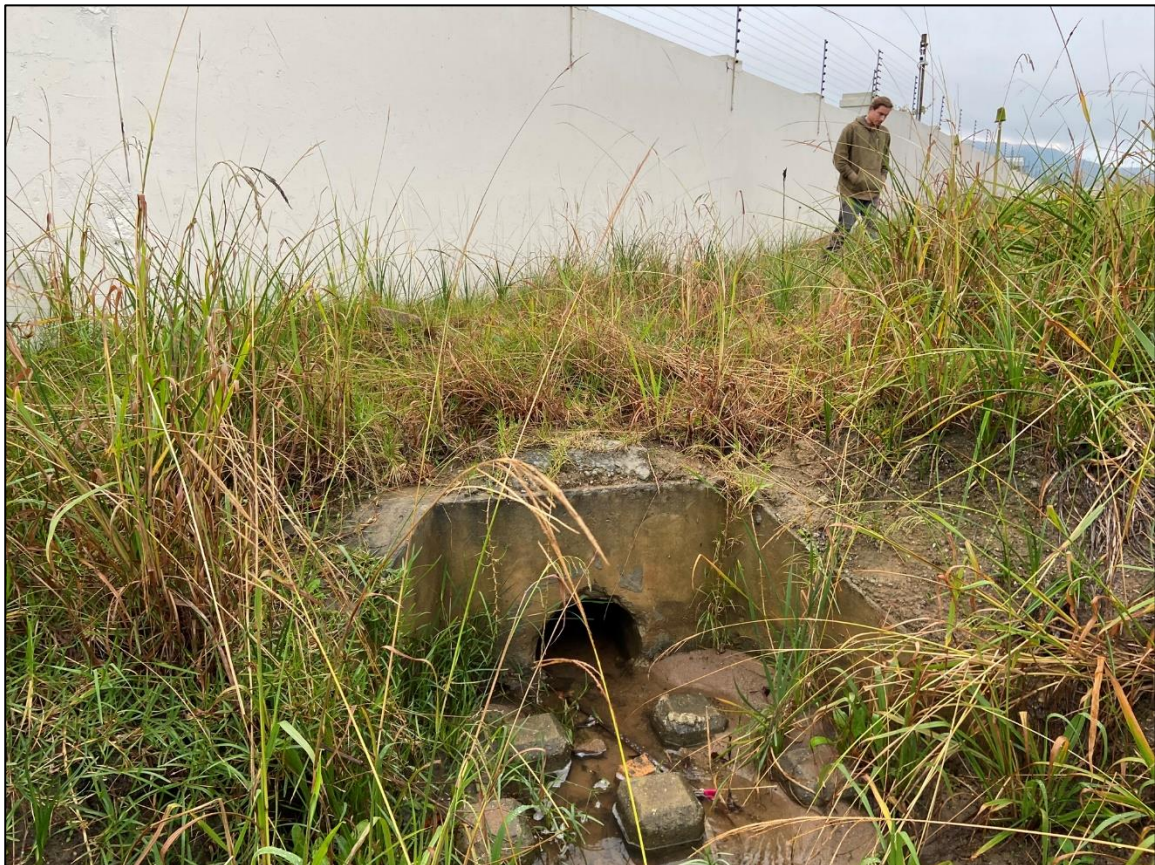
Figure 2: Image illustrating where the water enters the site through stormwater pipes along the northwestern border (June 2023).

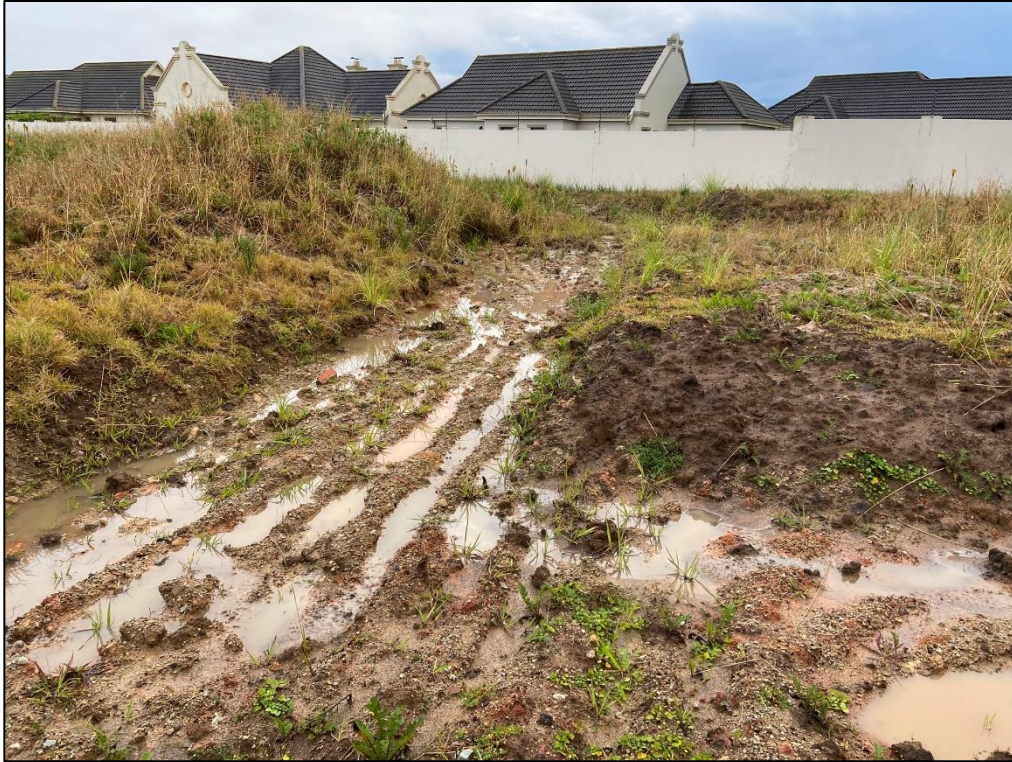
Figure 3: Image illustrating where furrows have been created to aid the drainage of stormwater on the site (June 2023).

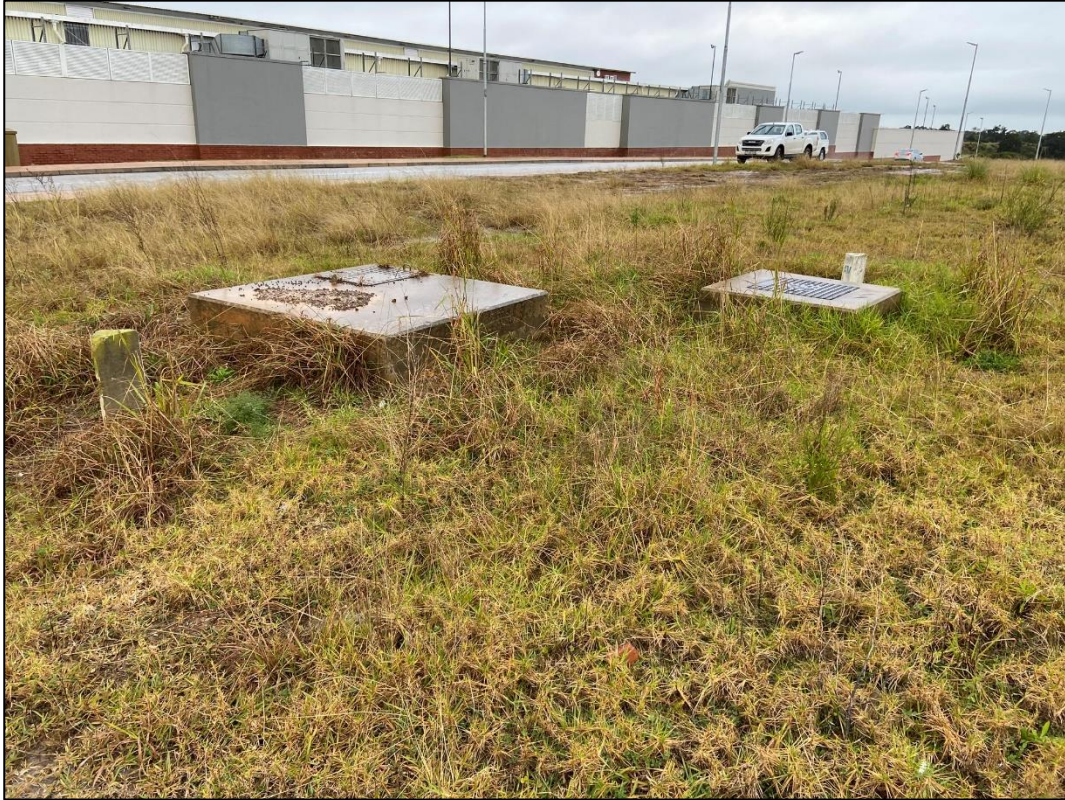
Figure 5: Image illustrating engineering services available at the site (June 2023).

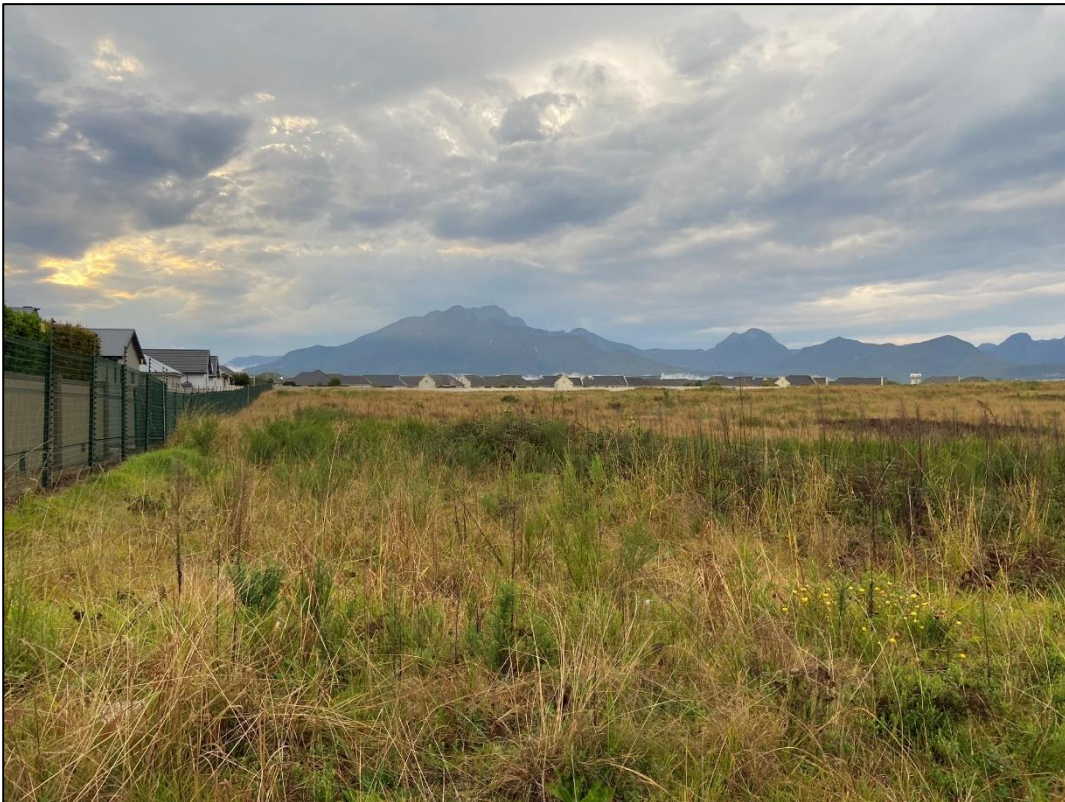
Figure 6: Image illustrating the dominant vegetation type on site (June 2023).

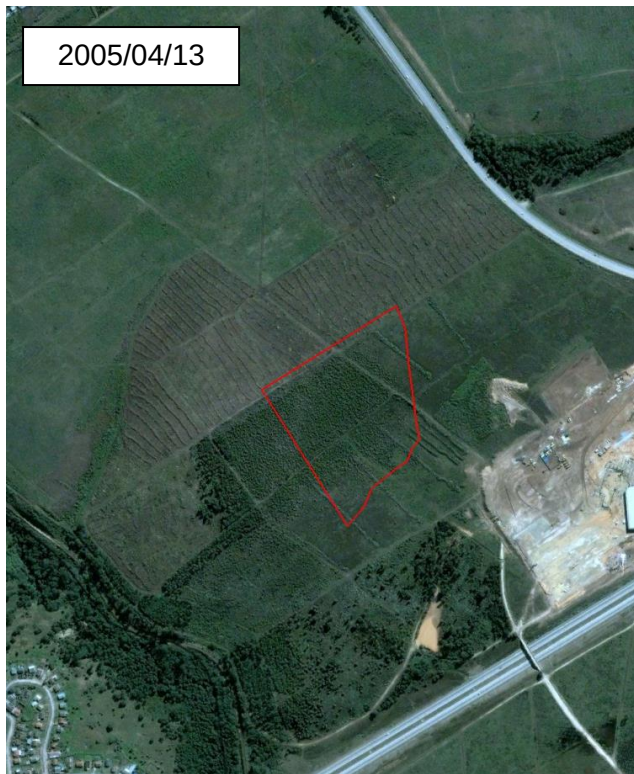
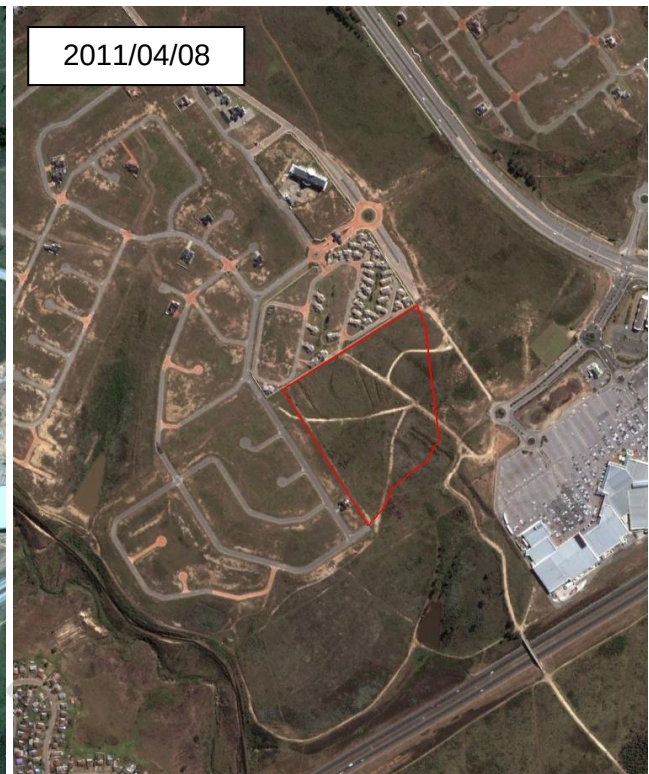
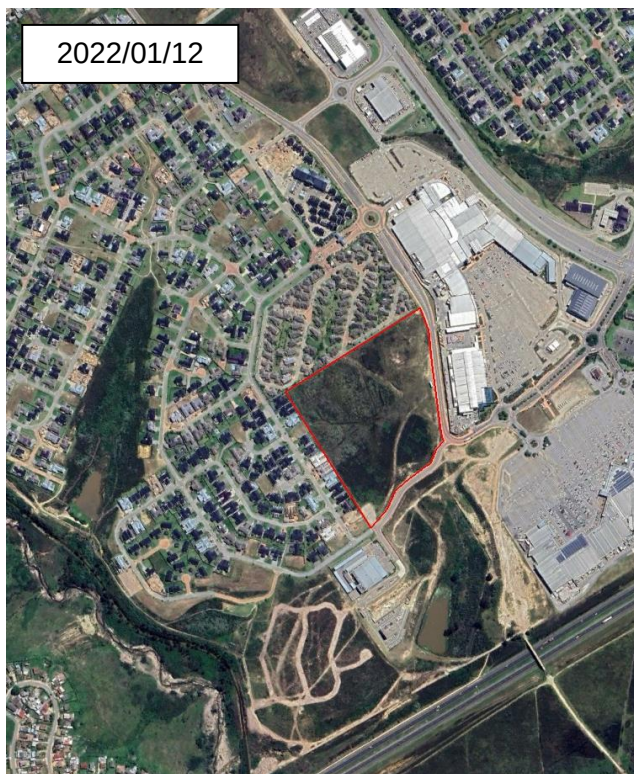
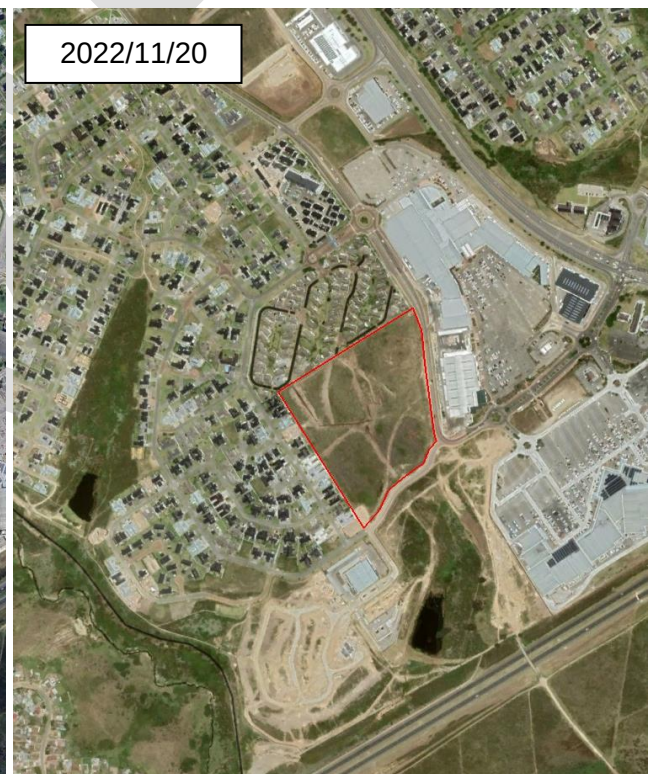
**Figure 5** Google Earth images (dates at the top left) of the site indicating the developing urban infrastructure and roads surrounding the site

The high-level Google Earth images (2005 to 2022) for the site are provided in **Figure 5**. These indicate the progression in urban development up to the present.

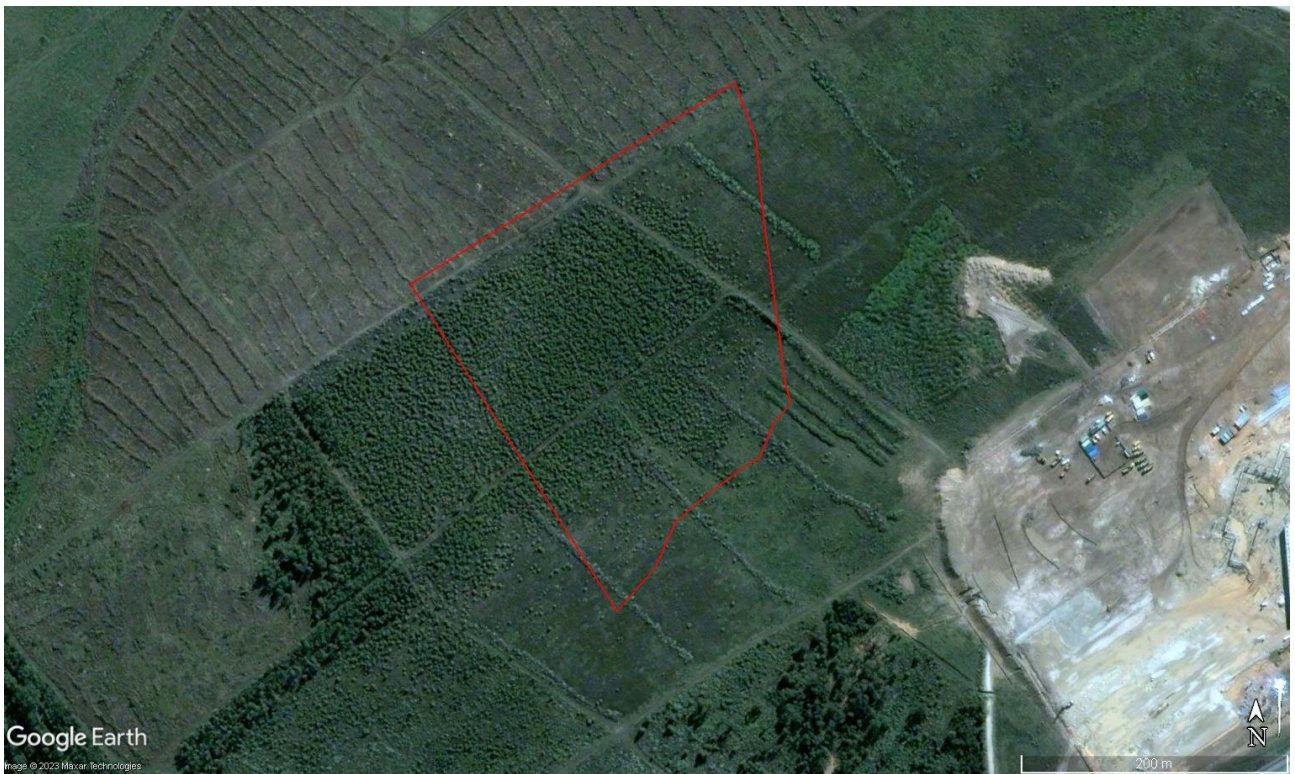
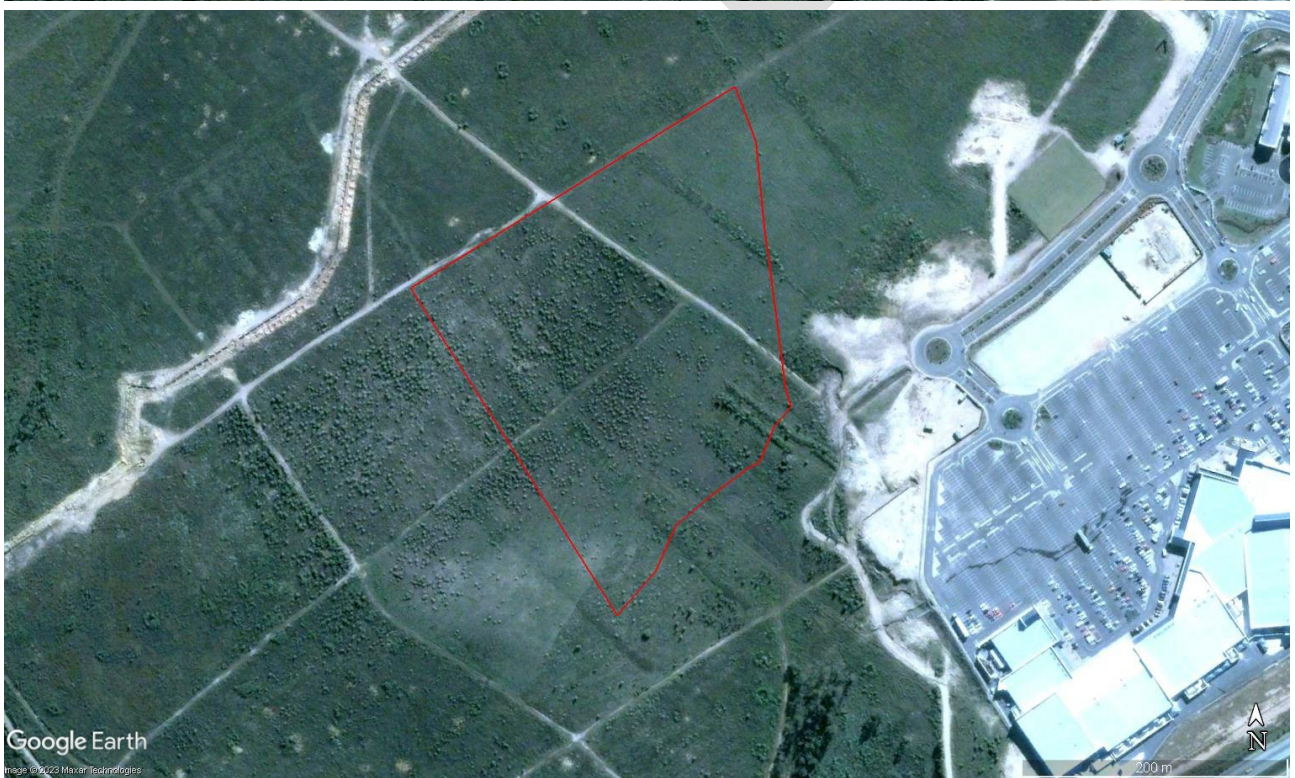
**Figure 6** Google Earth images (top: 2005/04/13; bottom: 2006/05/09) indicating an increasing urban footprint surrounding the site

The detailed level Google Earth images, ranging from 2005 to the 2022, are provided in **Figures 6 to 8**. These images indicate the development of stormwater ingress signatures and trenches as well as a developing associated vegetation signature in the lower portion of the site.

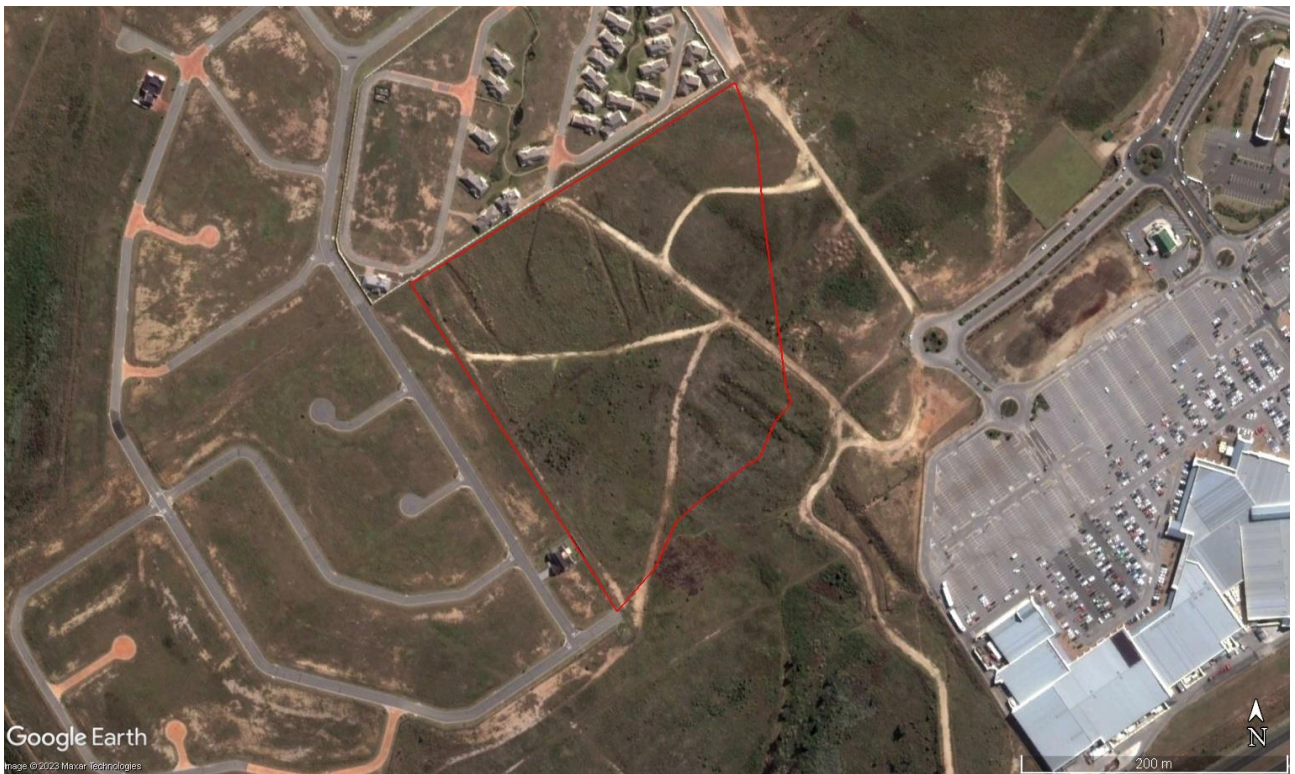
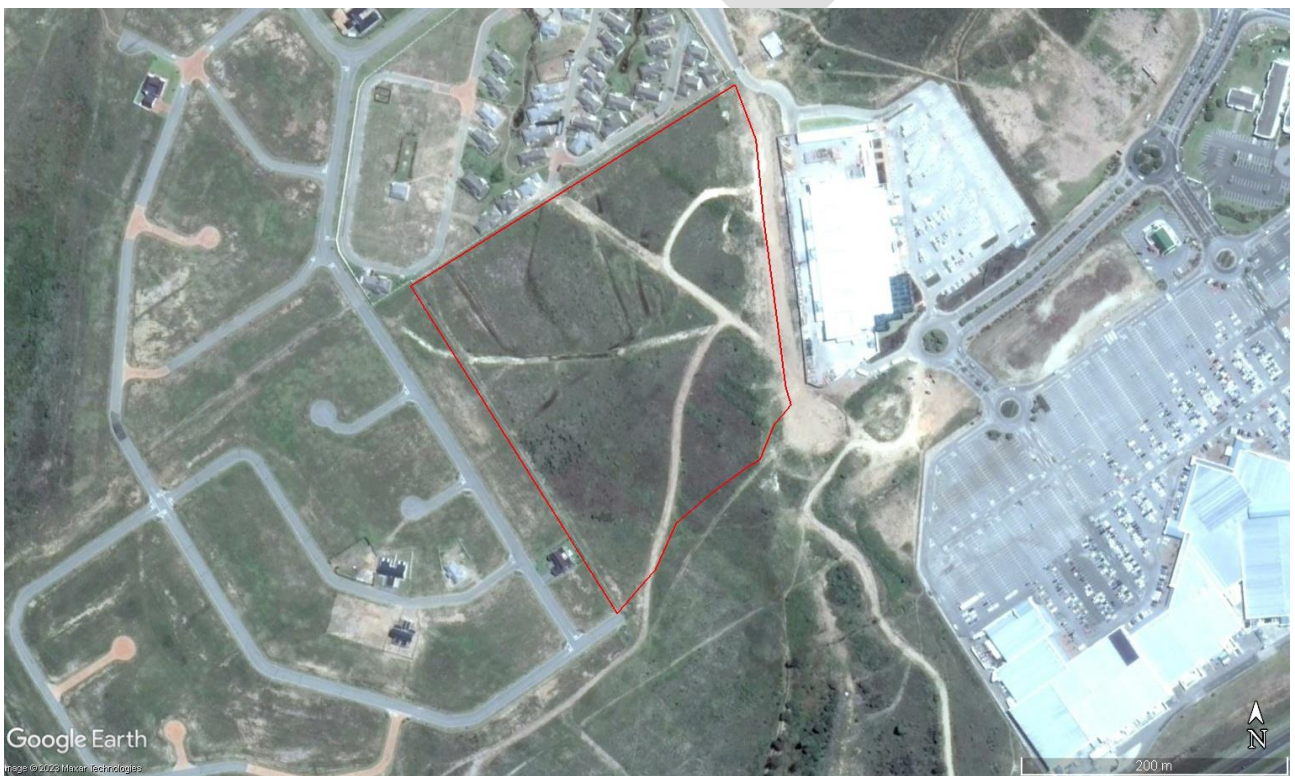
**Figure 7** Google Earth images (top: 2011/04/08; bottom: 2014/02/04) indicating dirt access roads and stormwater trenches on the site

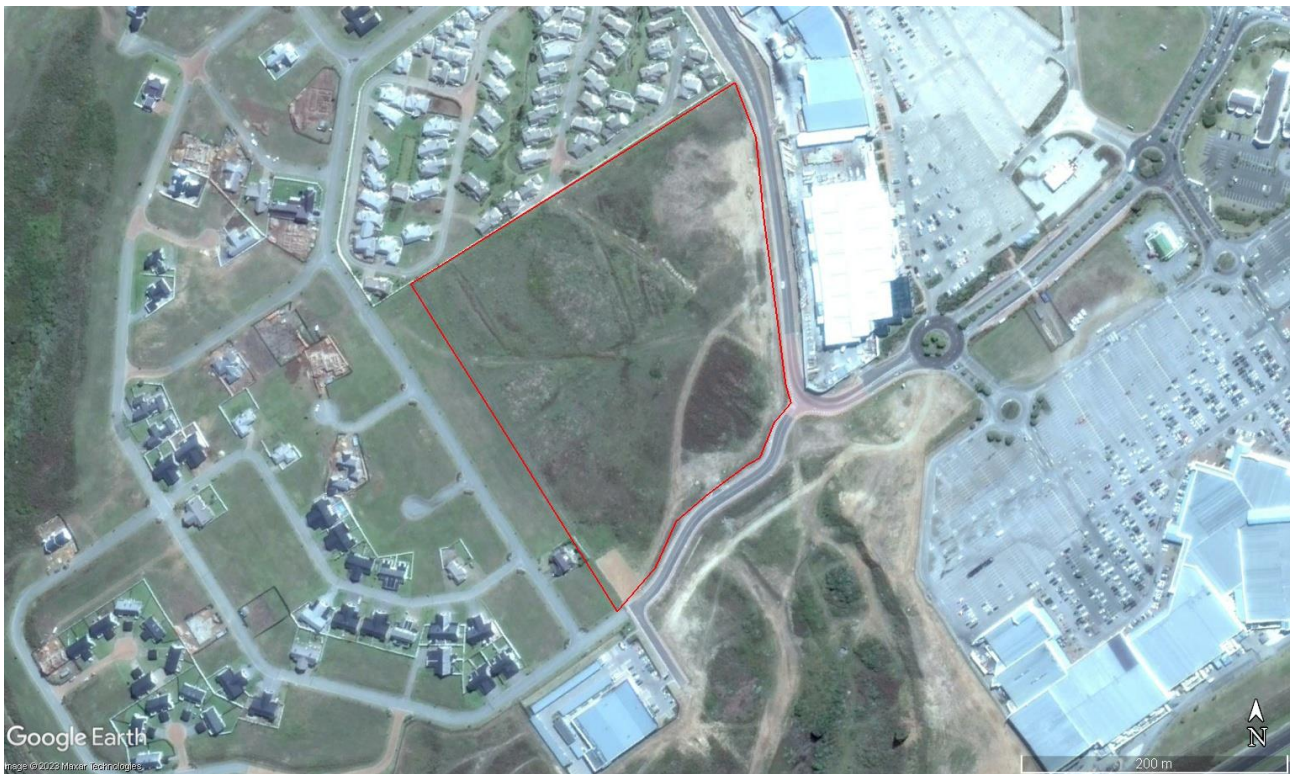
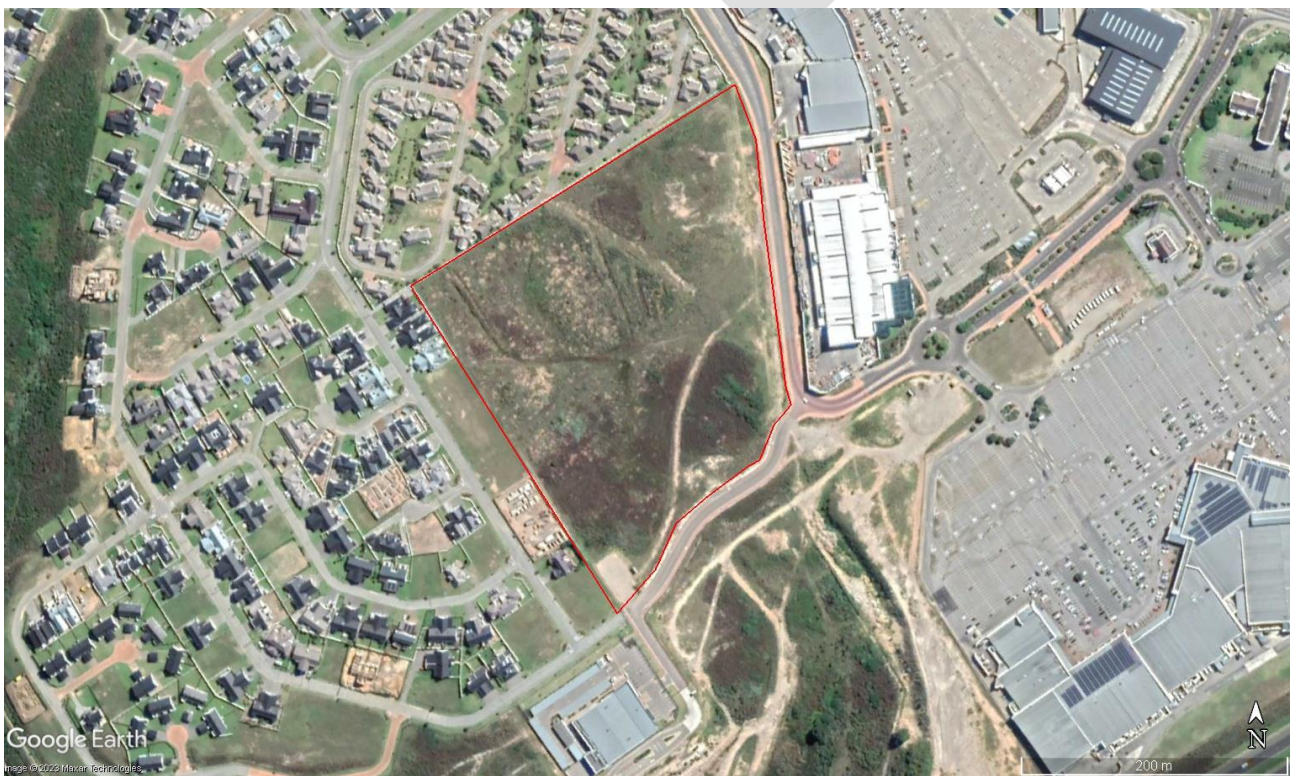
**Figure 8** Google Earth images (top: 2017/04/10; bottom: 2020/04/03) indicating developments with stormwater outlets onto the site surrounding it, as well as a developing wetness footprint

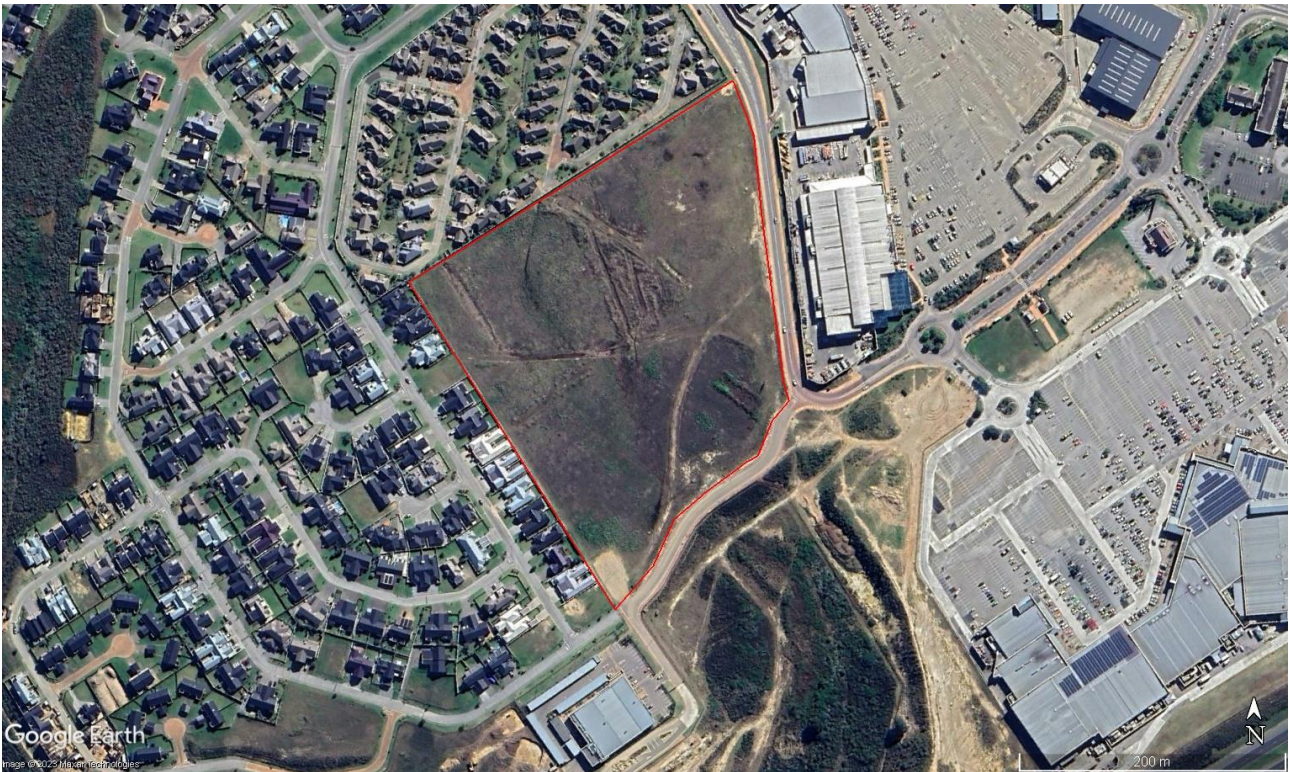
**Figure 9** Google Earth image (2022/08/31) indicating developments with stormwater outlets onto the site surrounding it and the resultant wetness footprint in the southern section
