**SCREENING REPORT FOR AN ENVIRONMENTAL AUTHORIZATION AS  
REQUIRED BY THE 2014 EIA REGULATIONS – PROPOSED SITE  
ENVIRONMENTAL SENSITIVITY**

**Project name:** EA Part 2 Amendment

**Project title:** Erf 28005, George

## **THE PROPOSED PART 2 EA AMENDMENT FOR RESIDENTIAL DEVELOPMENT ON ERF 28005, GEORGE**

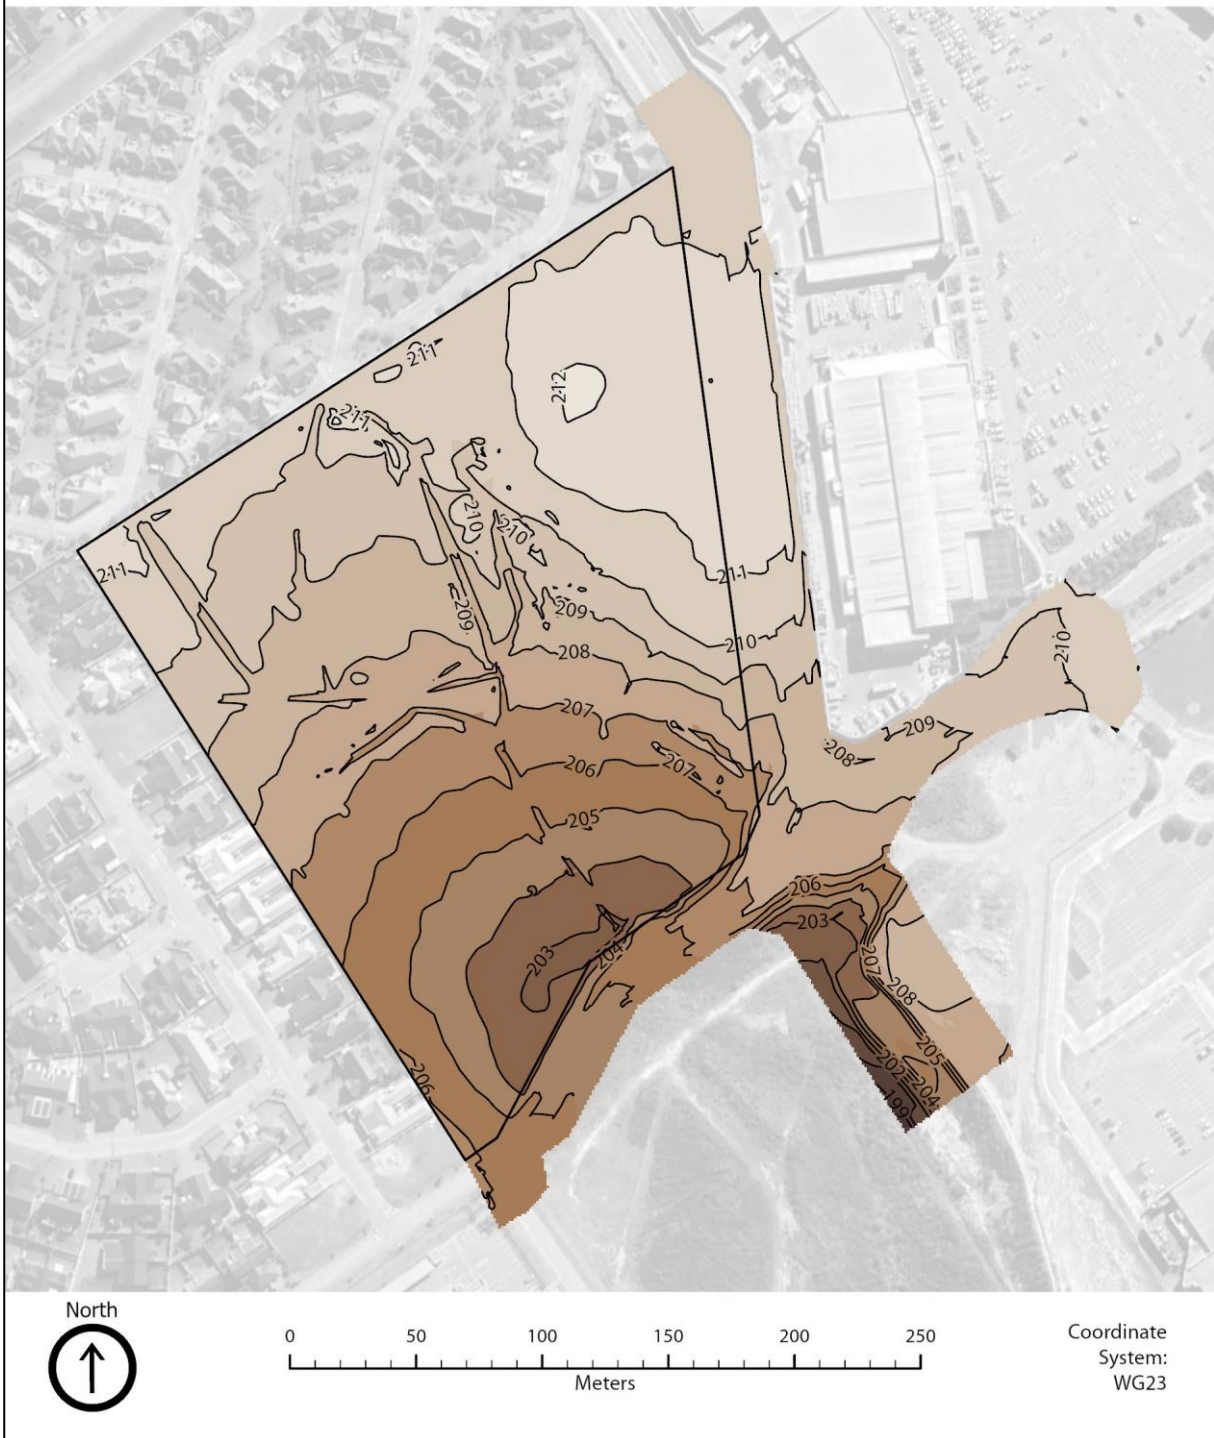
**ERF 28005 GEORGE**  
Elevation Model Built From Survey Data

The detailed contours for the stormwater plan are indicated as a DEM in **Figure 12** and as a TWI in **Figure 13**. These contours clearly indicate the excavated stormwater trenches as well as the elevated road (narrow sliver) signature on the site. It is apparent that these measures were implemented by surrounding developments to manage stormwater away from their sites.
